# System Resilience Against Major Earthquakes ~Learnings from the Hokkaido Blackout~

May 14<sup>th</sup> 2019 Manabu Nabeshima

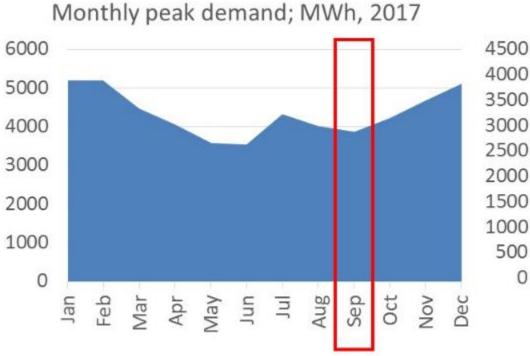
Hourly demand on the day of EQ; MWh

The earthquake hit Hokkaido when the demand was relatively small

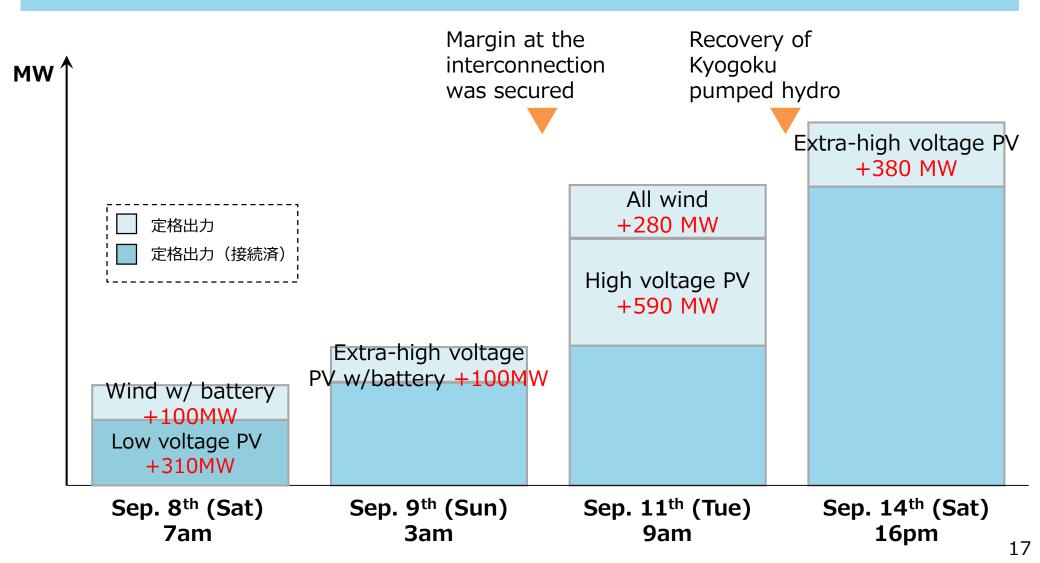
### **Recovery of RES**

It took a week for RES to recover to full operation due to lack of balancing capacity

**Sufficient balancing capacity** is required for RES to re-connect to the grid after blackout
