# Large Scale Blackout in Hokkaido Caused by the Earthquake on 6<sup>th</sup> September

8<sup>th</sup> November

Takuma INAMURA

Permanent Delegation of Japan to the OECD

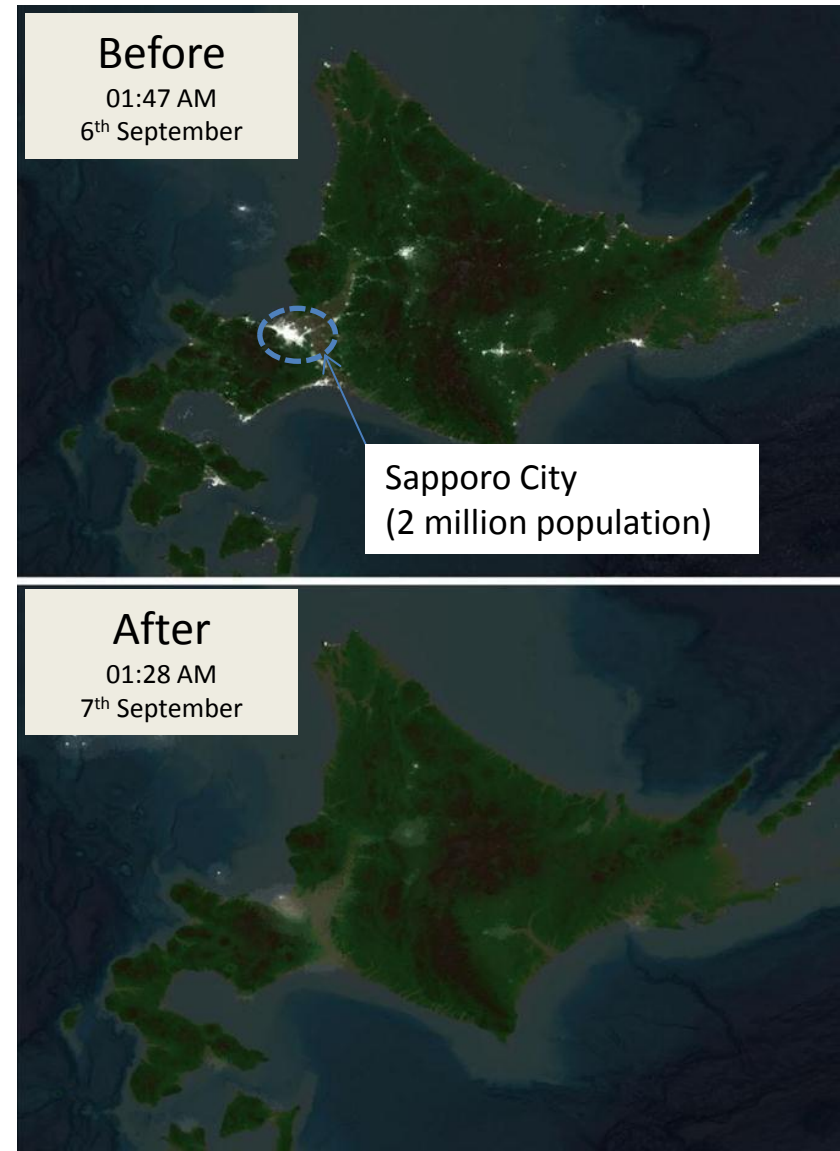
- Power plants and transmission lines near the epicenter were damaged by the strong tremor, which led to area-wide frequency fluctuation and the whole area being blacked out 17 minutes after the earthquake.
- First utility-area-wide blackout in Japan which involved 3 million households served by the Hokkaido Electric Company (HEPCO).
- The recovery of power supply to the whole area took 45 hours. Due to supply shortage, industries and households were requested to reduce their electricity demands for two weeks.

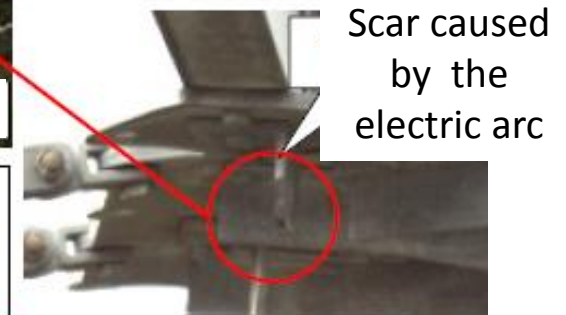
- Four transmission routes connecting eastern Hokkaido to the demand center were temporarily cut off by a ground fault.

It is estimated that the short circuit happened between an electric wire and a pylon due to the strong tremor.

- Temporary transmission cut caused a frequency spike in eastern Hokkaido and undamaged hydro power plants (0.4 GW) were stopped by OFR.
